Errata to EPROM Emulator NG, PCB versions 1.6 and below.

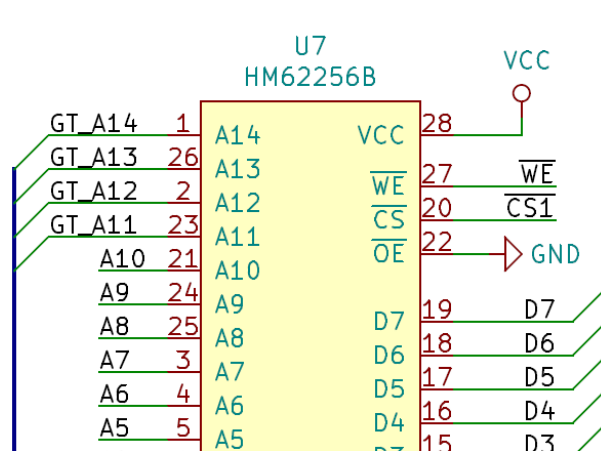
Dear users of the EPROM Emulator NG, I recently discovered a potential flaw in the design of the emulator. Refer to the diagram of the emulator posted to GitHub dated (2020-05-05), parts shown here:

As you can see, the /OE line (pin 22) is connected to ground (GND), permanently enabling the output of the one of the SRAMs at any point of time (the other control line /CS is driven by the state of address line A15). This creates a potential issue, when the emulator is waiting for data from the computer and the shift registers are enabled, driving at the same time the data bus. This situation continues until data from computer or the SPI EEPROM is loaded into SRAM and the “emulation” starts (shift registers get disabled and external buffers - 74HC541 enabled). In my initial design and prototype of the emulator I had those lines correctly connected to the “Reset” signal, this way it guarantees only one of those can be active on the data line at any point, but while I was troubleshooting a completely unrelated issue I disconnected the OE lines from Reset and connected them to GND, I carried over the flawed design to later releases of the PCBs and only just noticed the mistake.

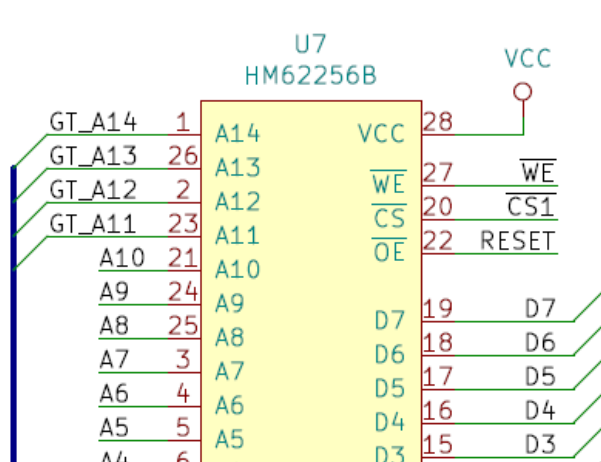
Interestingly this has not caused any functional issue for the many emulators that are currently in use, they are working and serving many of you very well, never the less I will publish updated diagram and new PCB design (1.7), the correct way to connect the SRAM is as follows:

New builds of the emulator should follow the corrected design and the new PCB layout. For current users I recommend doing **ONE** of the following:
