Errata 1 to EPROM Emulator NG, PCB versions 1.6 and below.

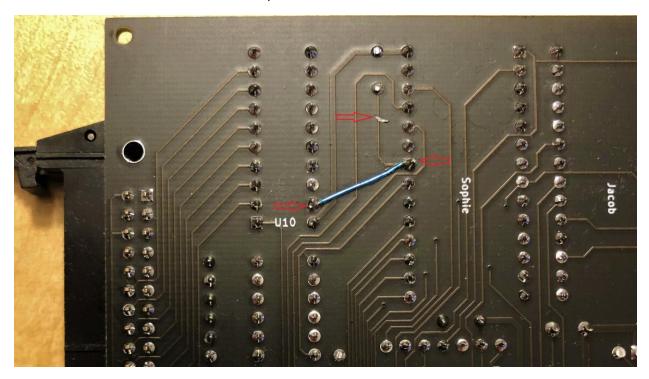
As you can see, the /OE line (pin 22) is connected to ground (GND), permanently enabling the output of the one of the SRAMs at any point of time (the other control line /CS is driven by the state of address line A15). This creates a potential issue, when the emulator is waiting for data from the computer and the shift registers are enabled, driving at the same time the data bus. This situation continues until data from computer or the SPI EEPROM is loaded into SRAM and the "emulation" starts (shift registers get disabled and external buffers - 74HC541 enabled). In my initial design and prototype of the emulator I had those lines correctly connected to the "Reset" signal, this way it guarantees only one of those can be active on the data line at any point, but while I was troubleshooting a completely unrelated issue I disconnected the OE lines from Reset and connected them to GND, I carried over the flawed design to later releases of the PCBs and only just noticed the mistake.

Option A: Hardware modification of the PCB: very simple, cut one track to separate the /CS line from GND, and run a short link of wire to connect the /CS to RESET:
