6 Speed Transmission mechatronic sleeve replacement

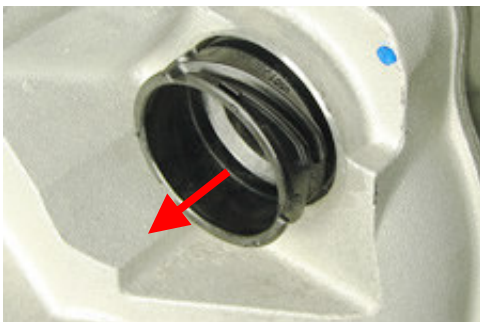
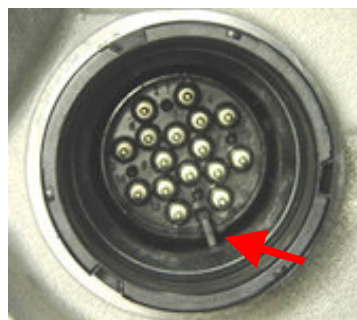
4. **Pull out the sealing sleeve without twisting or rotating motion.**
The sleeve has a locating tab that might come in touch with the connector pins and cause damage.
