Sheet: /		Date: 2020-02-27	
File: hw72nb.sch		Rev: R0.1	
Size: A	REF	KiCad E.D.A. kicad (5.1.5)-3	
Title:		Id: 1/4

https://rusefi.com/wiki/index.php?title=Vehicle:Mazda_Miata_2003

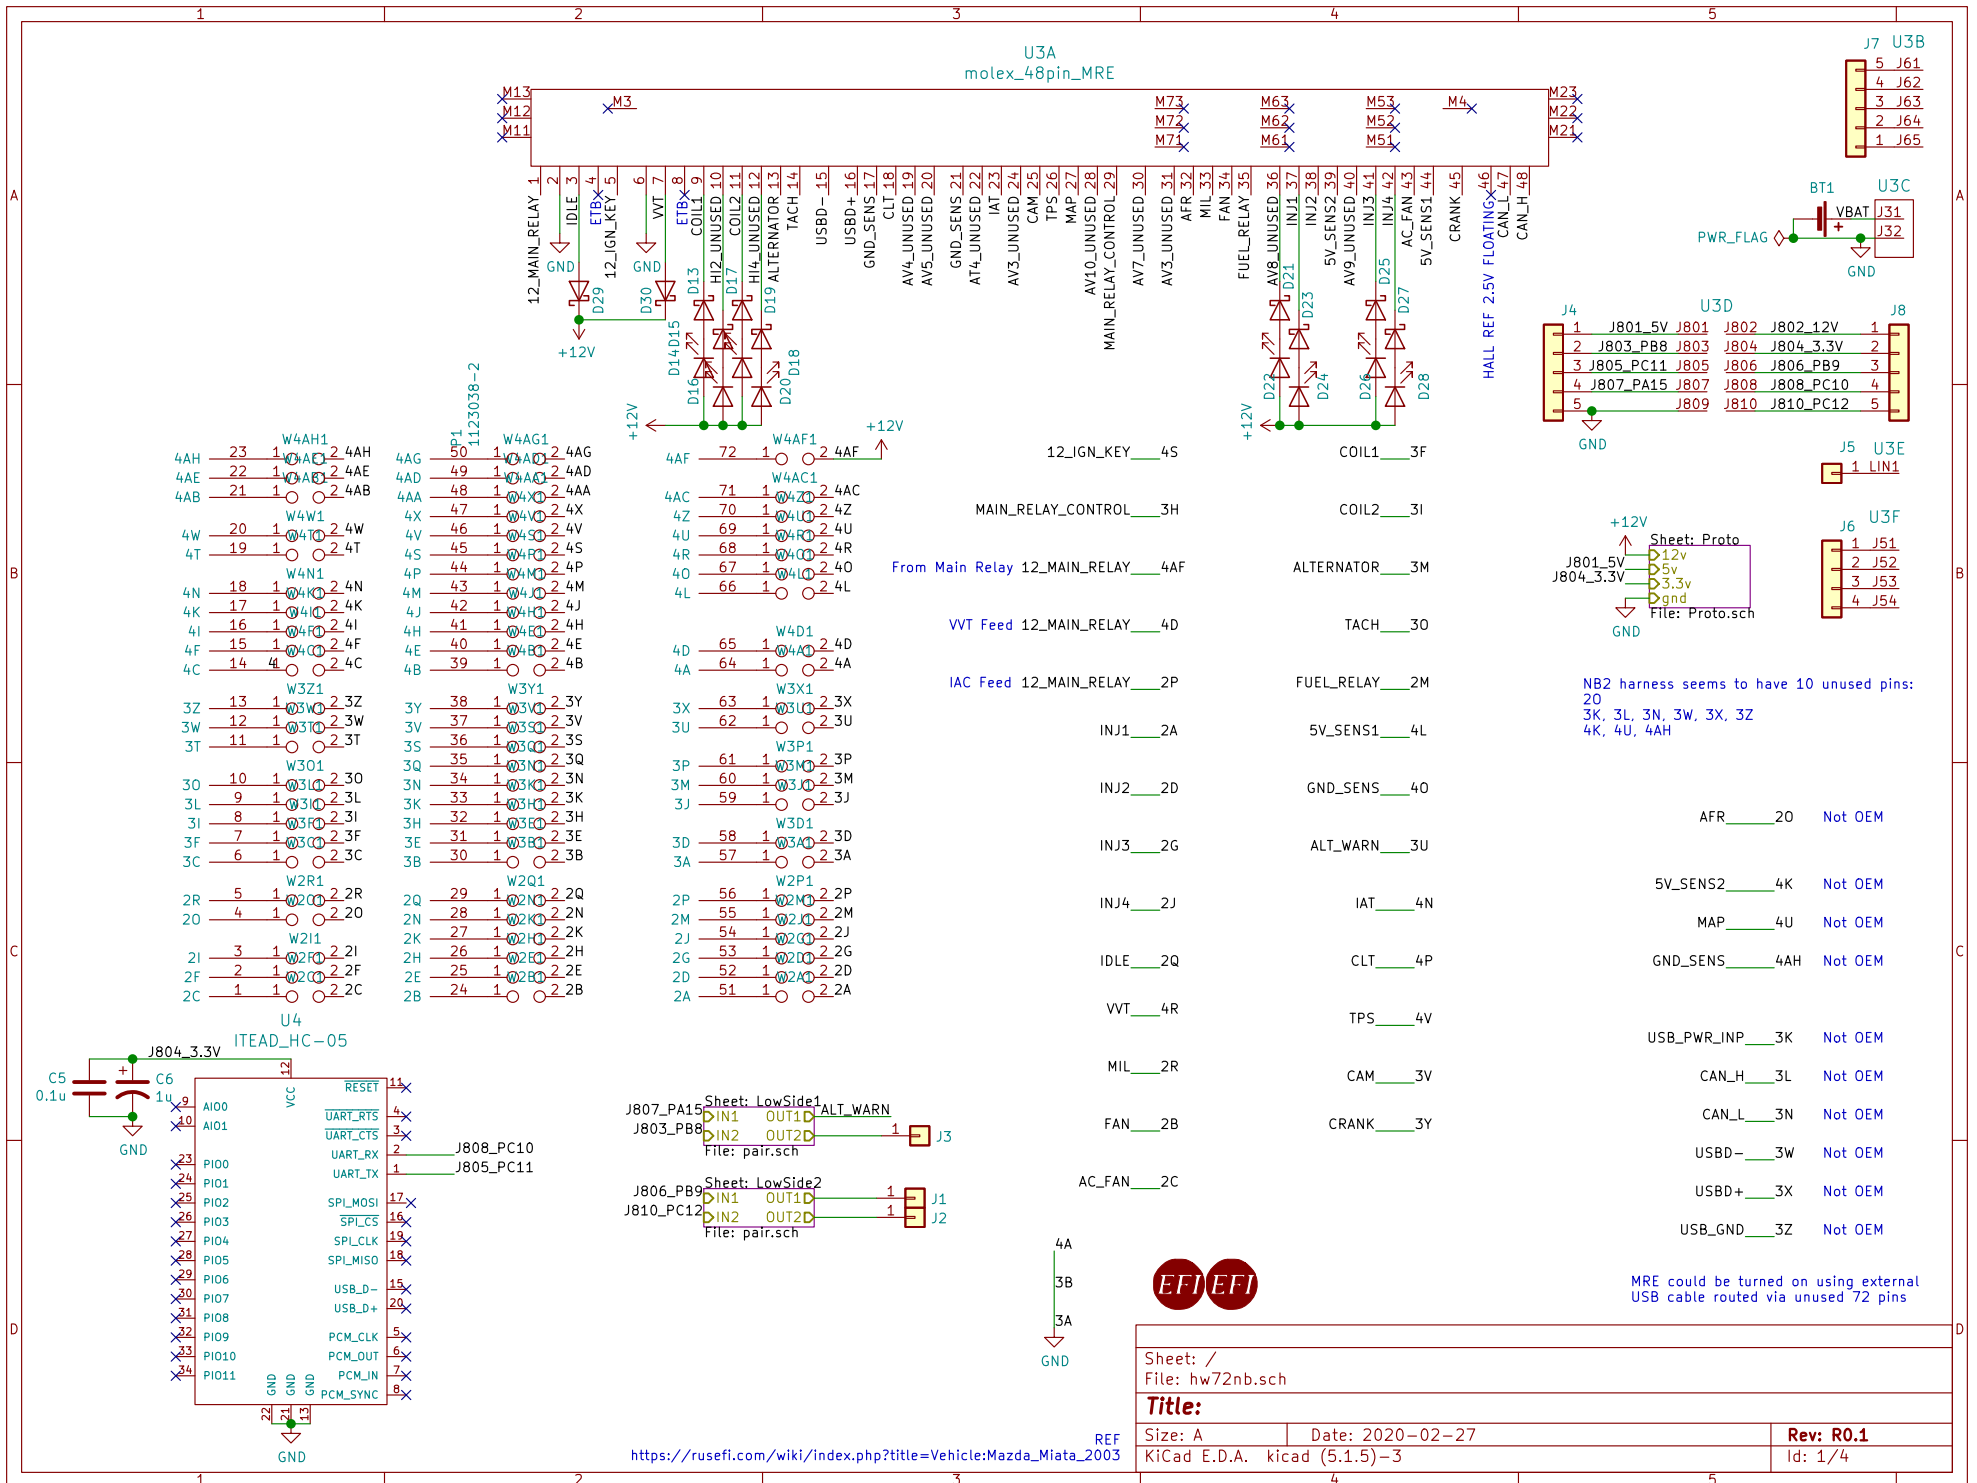
NB2 harness seems to have 10 unused pins:
 20
 3K, 3L, 3N, 3W, 3X, 3Z
 4K, 4U, 4A, 4H

- AFR ___20 Not OEM
- 5V_SENS2 ___4K Not OEM
- MAP ___4U Not OEM
- GND_SENS ___4AH Not OEM
- USB_PWR_INP ___3K Not OEM
- CAN_H ___3L Not OEM
- CAN_L ___3N Not OEM
- USB_D- ___3W Not OEM
- USB_D+ ___3X Not OEM
- USB_GND ___3Z Not OEM

MRE could be turned on using external USB cable routed via unused 72 pins
